Logbook Photo #	SDC10033
US EPA ID / Task Order Number	CERCLIS No. LAD008434185 / 2/Dynamac-077-15-001
Site	SBA Shipyard, Inc. – Removal Assessment (RA)
Location Address	9040 Castex Landing Road
City, State	Jennings, Louisiana
Parish	Jefferson Davis
Direction/Orientation	NW
Date	10/15/14
Time	0853 hrs
Photographer	J. Sherrard (START)
Witness	N. Biscocho (START)
Description:	
Current condition of the buried barge associated with the alkyne storage tank pump house.	
Southeast corner of the alkyne storage tank pump house facing northwest toward the barge slip inlet.

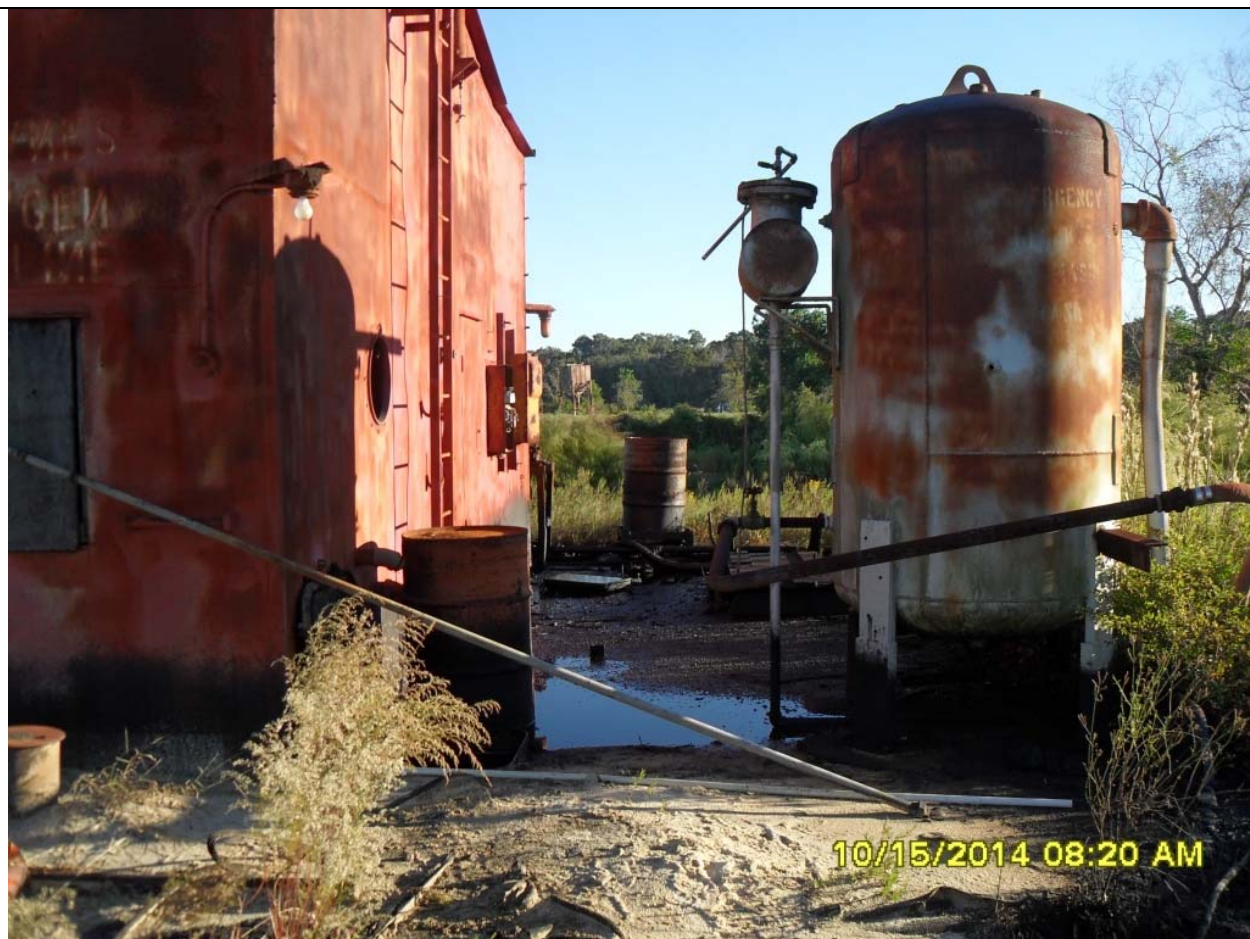
Logbook Photo #	SDC10013
US EPA ID / Task Order Number	CERCLIS No. LAD008434185 / 2/Dynamac-077-15-001
Site	SBA Shipyard, Inc. – Removal Assessment (RA)
Location Address	9040 Castex Landing Road
City, State	Jennings, Louisiana
Parish	Jefferson Davis
Direction/Orientation	N
Date	10/15/14
Time	0820 hrs
Photographer	N. Biscocho (START)
Witness	J. Sherrard (START)
Description: Current condition of the buried barge associated with the alkyne storage tank pump house. East wall of the alkyne storage tank pump house facing west toward the barge slip inlet.

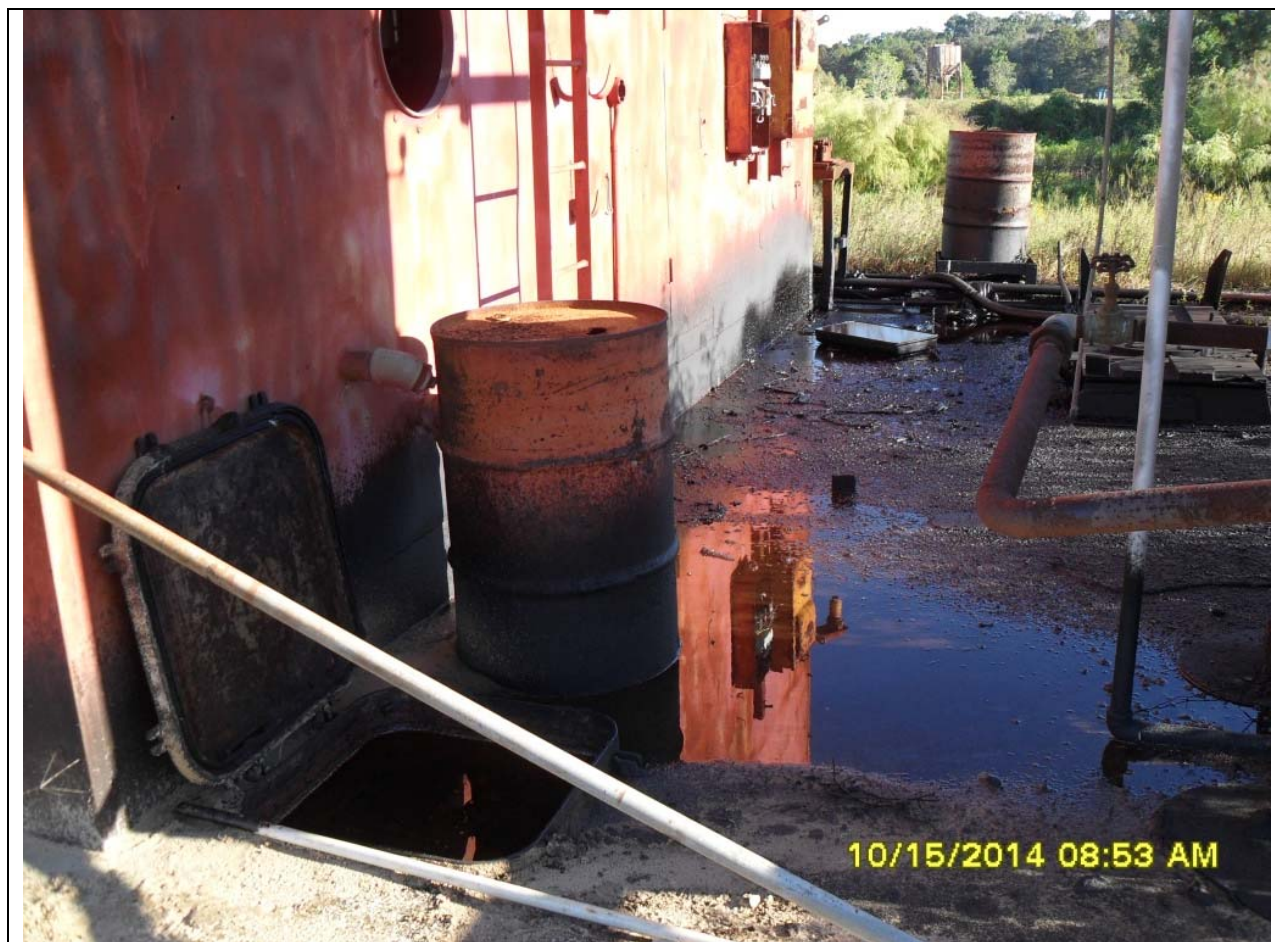
Logbook Photo #	SDC10035
US EPA ID / Task Order Number	CERCLIS No. LAD008434185 / 2/Dynamac-077-15-001
Site	SBA Shipyard, Inc. – Removal Assessment (RA)
Location Address	9040 Castex Landing Road
City, State	Jennings, Louisiana
Parish	Jefferson Davis
Direction/Orientation	N
Date	10/15/14
Time	0853 hrs
Photographer	J. Sherrard (START)
Witness	N. Biscocho (START)
Description:	<p>Hatch on the east wall of the alkyne storage tank pump house visible on the buried barge.</p> <p>Stained soils observed around the hatch and along the east wall of the alkyne storage tank pump house.</p>

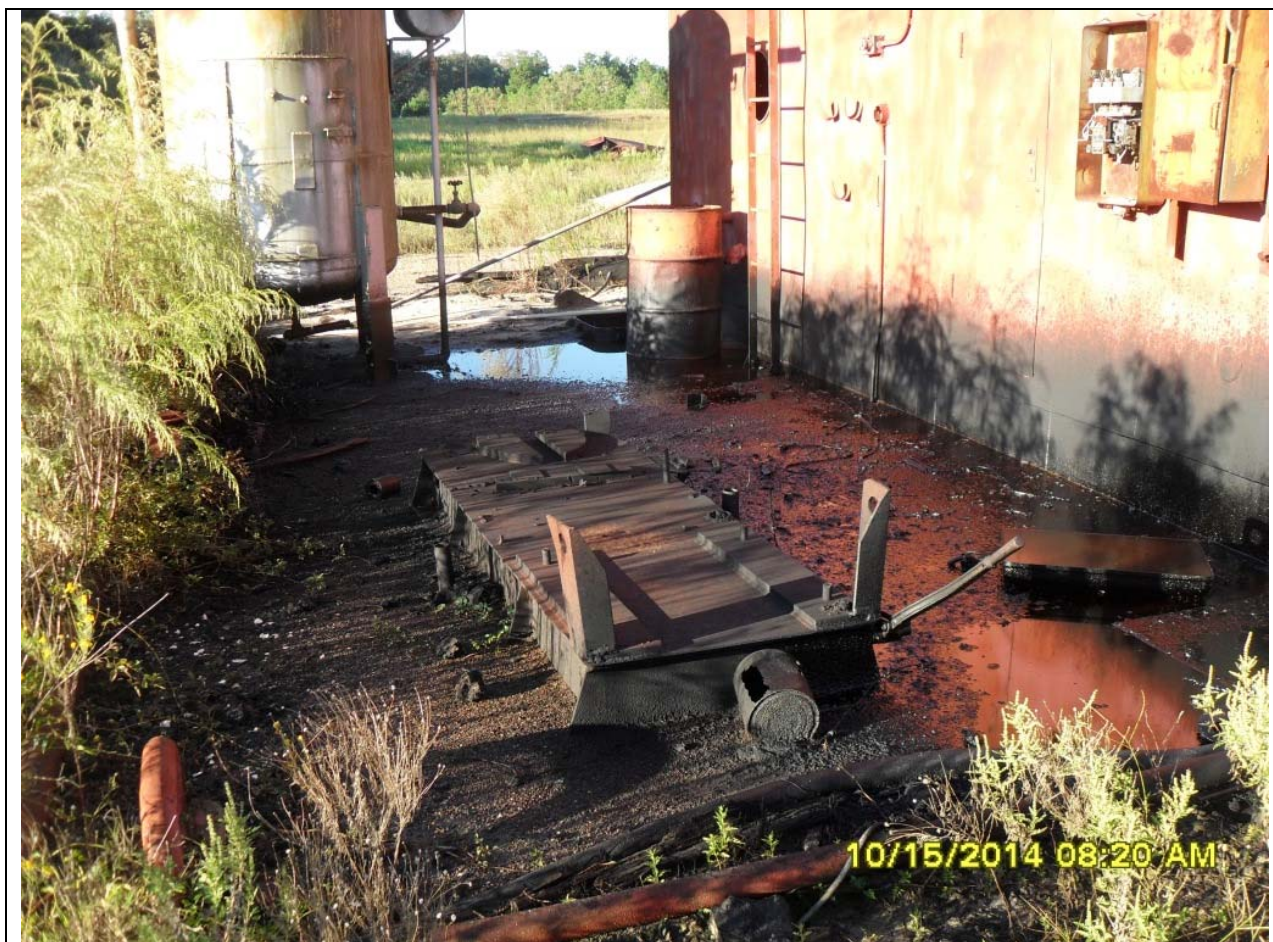
Logbook Photo #	SDC10015
US EPA ID / Task Order Number	CERCLIS No. LAD008434185 / 2/Dynamac-077-15-001
Site	SBA Shipyard, Inc. – Removal Assessment (RA)
Location Address	9040 Castex Landing Road
City, State	Jennings, Louisiana
Parish	Jefferson Davis
Direction/Orientation	SW
Date	10/15/14
Time	0820 hrs
Photographer	N. Biscocho (START)
Witness	J. Sherrard (START)
Description:	<p>Current condition of the alkyne storage tank pump house visible on the buried barge.</p> <p>East wall of the alkyne storage tank pump house facing southwest. Stained soils observed.</p>

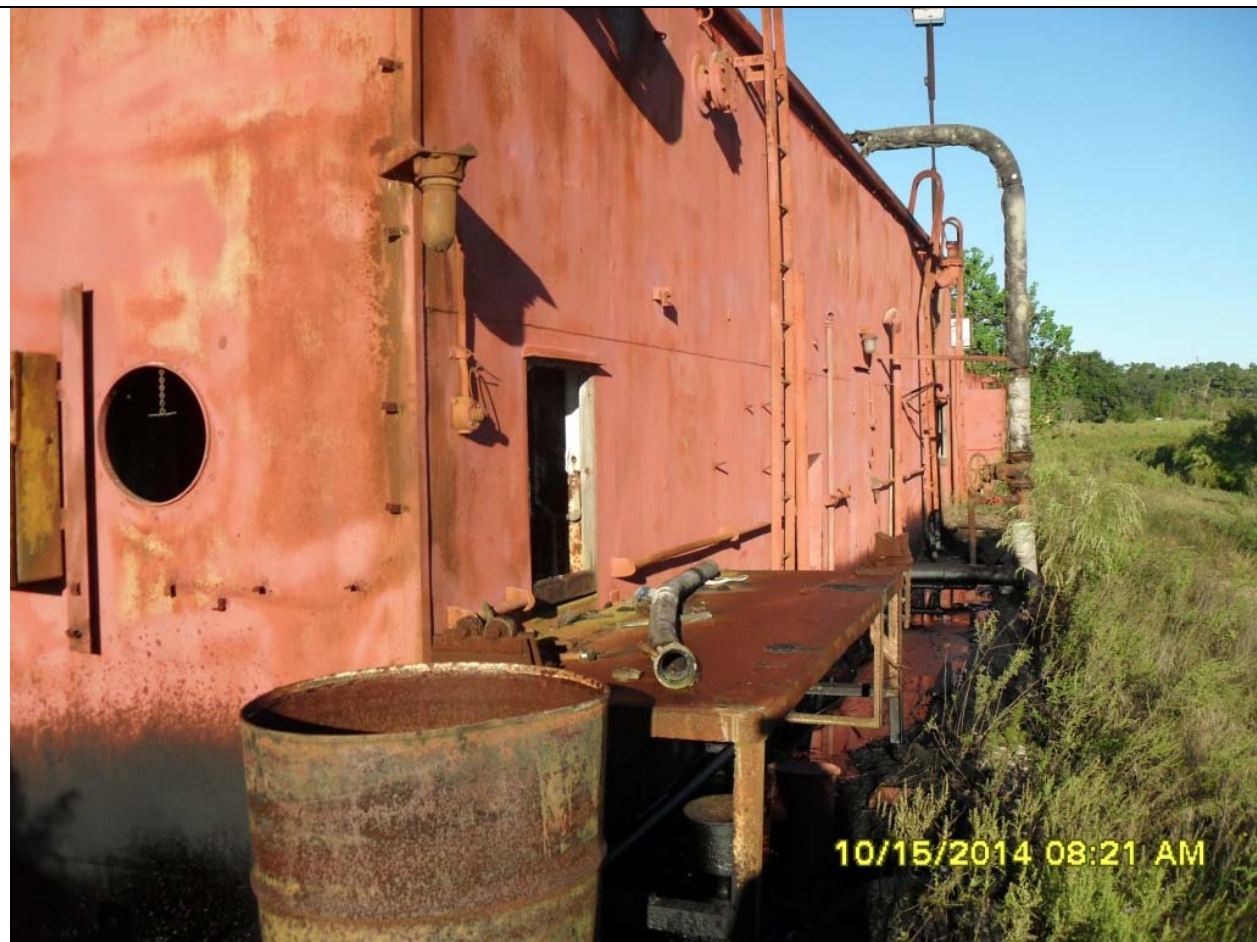
Logbook Photo #	SDC10016
US EPA ID / Task Order Number	CERCLIS No. LAD008434185 / 2/Dynamac-077-15-001
Site	SBA Shipyard, Inc. – Removal Assessment (RA)
Location Address	9040 Castex Landing Road
City, State	Jennings, Louisiana
Parish	Jefferson Davis
Direction/Orientation	W
Date	10/15/14
Time	0821 hrs
Photographer	N. Biscocho (START)
Witness	J. Sherrard (START)
Description: Current condition of the alkyne storage tank pump house visible on the buried barge. North wall of the alkyne storage tank pump house facing west.

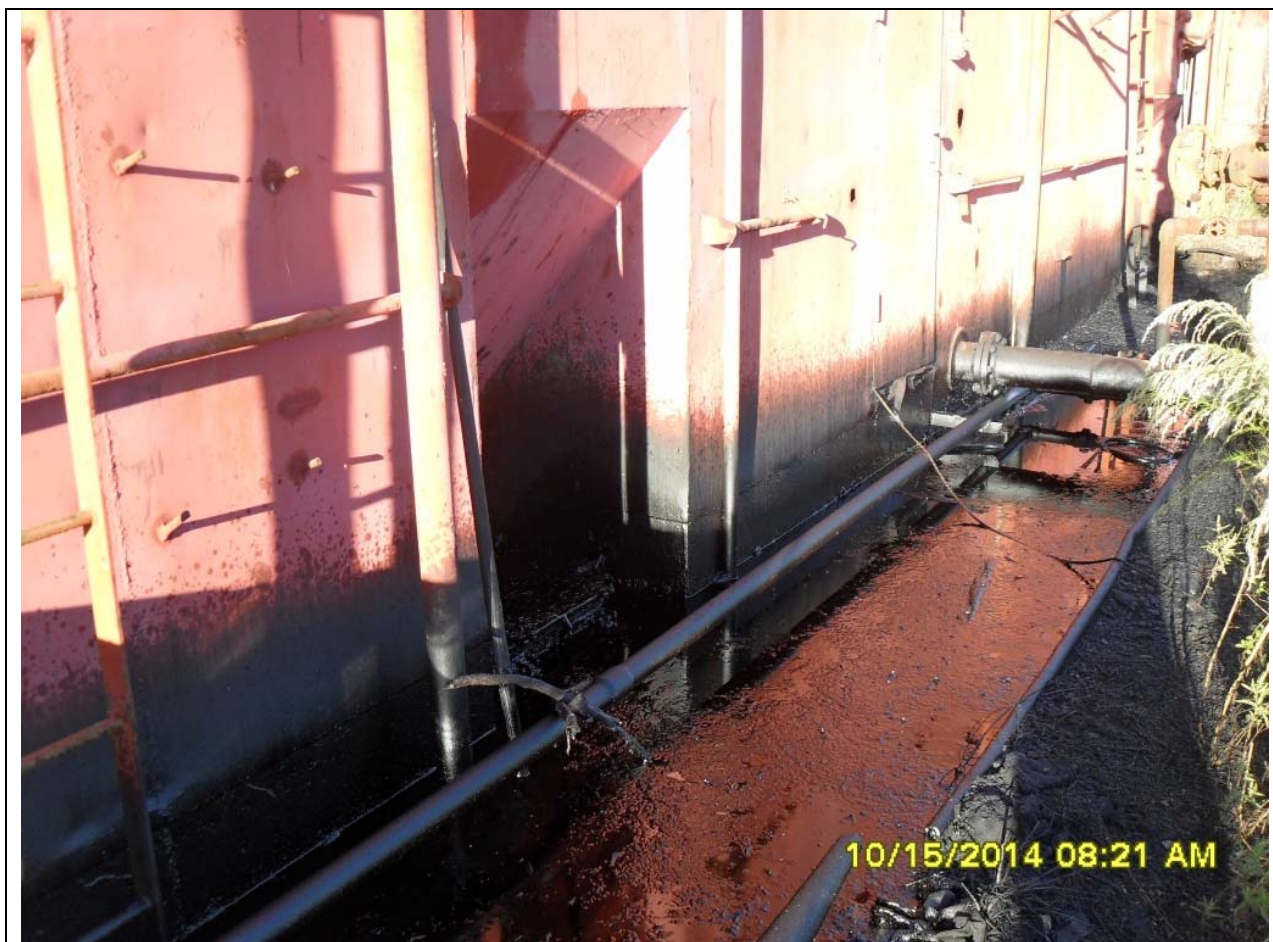
Logbook Photo #	SDC10017
US EPA ID / Task Order Number	CERCLIS No. LAD008434185 / 2/Dynamac-077-15-001
Site	SBA Shipyard, Inc. – Removal Assessment (RA)
Location Address	9040 Castex Landing Road
City, State	Jennings, Louisiana
Parish	Jefferson Davis
Direction/Orientation	W
Date	10/15/14
Time	0821 hrs
Photographer	N. Biscocho (START)
Witness	J. Sherrard (START)
Description:	<p>Current condition of the alkyne storage tank pump house visible on the buried barge.</p> <p>North wall of the alkyne storage tank pump house facing west. Stained soils observed.</p>

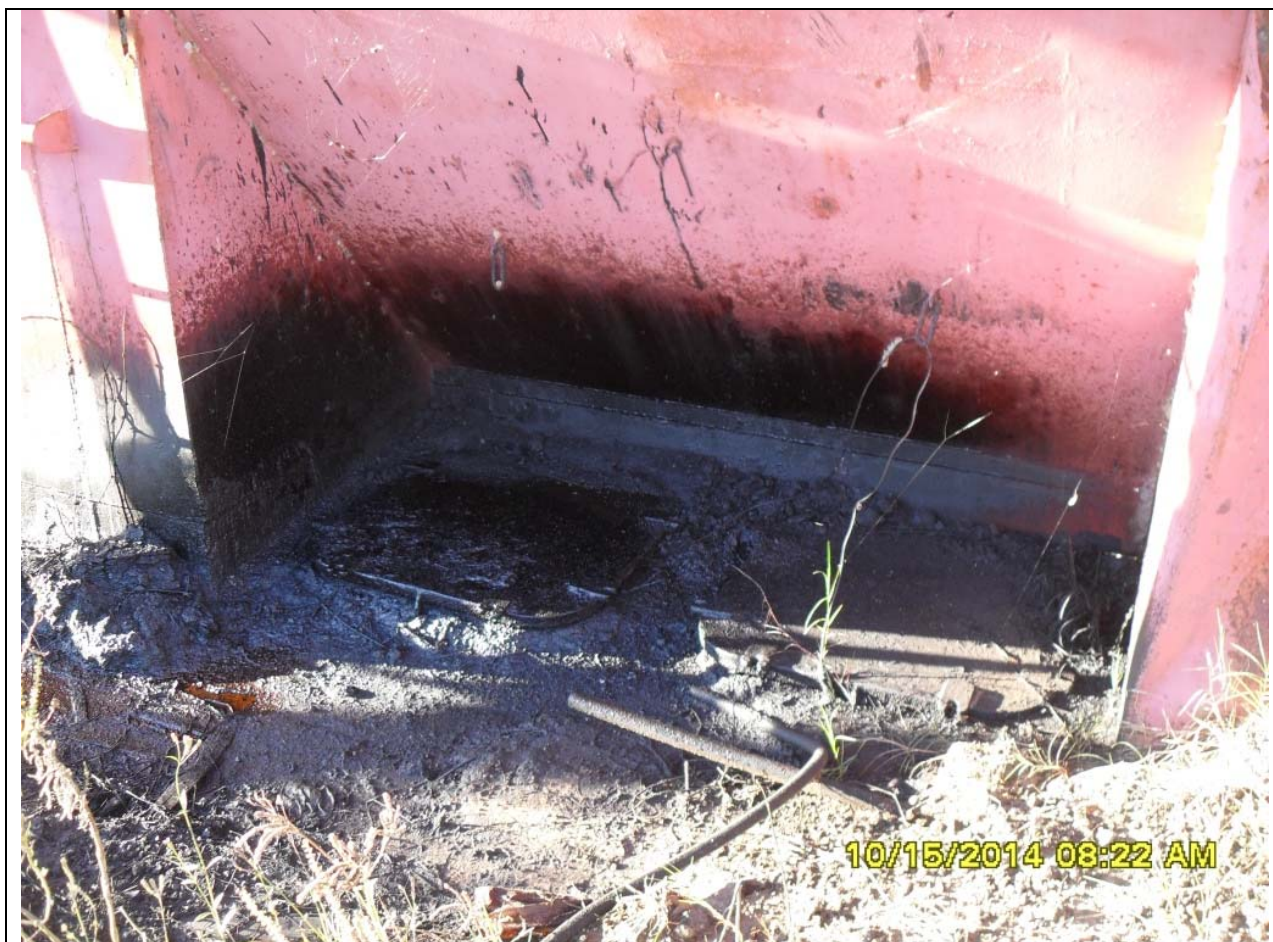
Logbook Photo #	SDC10019
US EPA ID / Task Order Number	CERCLIS No. LAD008434185 / 2/Dynamac-077-15-001
Site	SBA Shipyard, Inc. – Removal Assessment (RA)
Location Address	9040 Castex Landing Road
City, State	Jennings, Louisiana
Parish	Jefferson Davis
Direction/Orientation	S
Date	10/15/14
Time	0822 hrs
Photographer	N. Biscocho (START)
Witness	J. Sherrard (START)
Description:	<p>Hatch on the buried barge along the north wall of the associated alkyne storage tank pump house.</p> <p>Stained soils observed around the hatch and along the north wall of the alkyne storage tank pump house.</p>

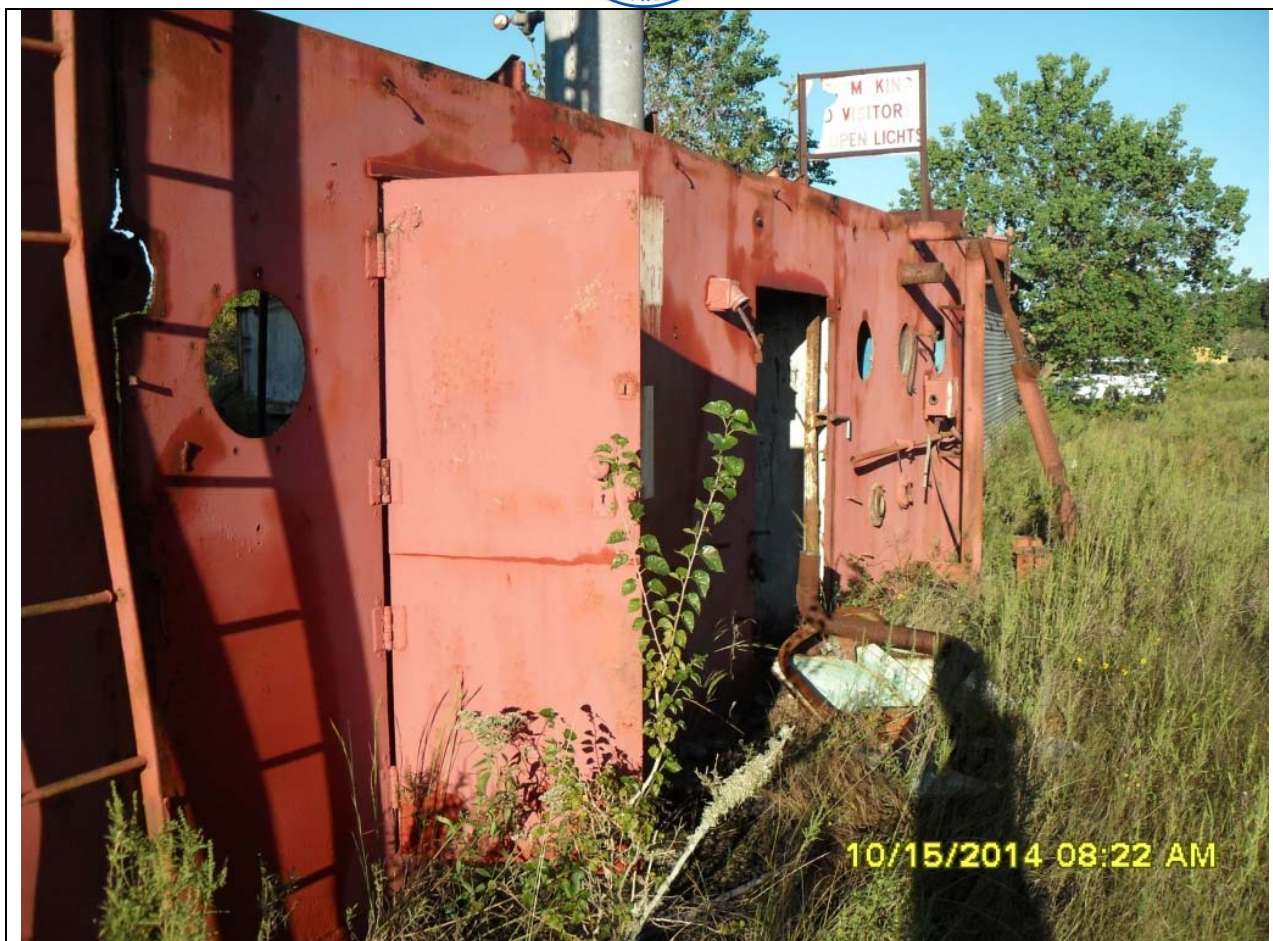
Logbook Photo #	SDC10020
US EPA ID / Task Order Number	CERCLIS No. LAD008434185 / 2/Dynamac-077-15-001
Site	SBA Shipyard, Inc. – Removal Assessment (RA)
Location Address	9040 Castex Landing Road
City, State	Jennings, Louisiana
Parish	Jefferson Davis
Direction/Orientation	SW
Date	10/15/14
Time	0822 hrs
Photographer	N. Biscocho (START)
Witness	J. Sherrard (START)
Description:	<p>Current condition of the alkyne storage tank pump house visible on the buried barge.</p> <p>North wall of the alkyne storage tank pump house facing southwest.</p>

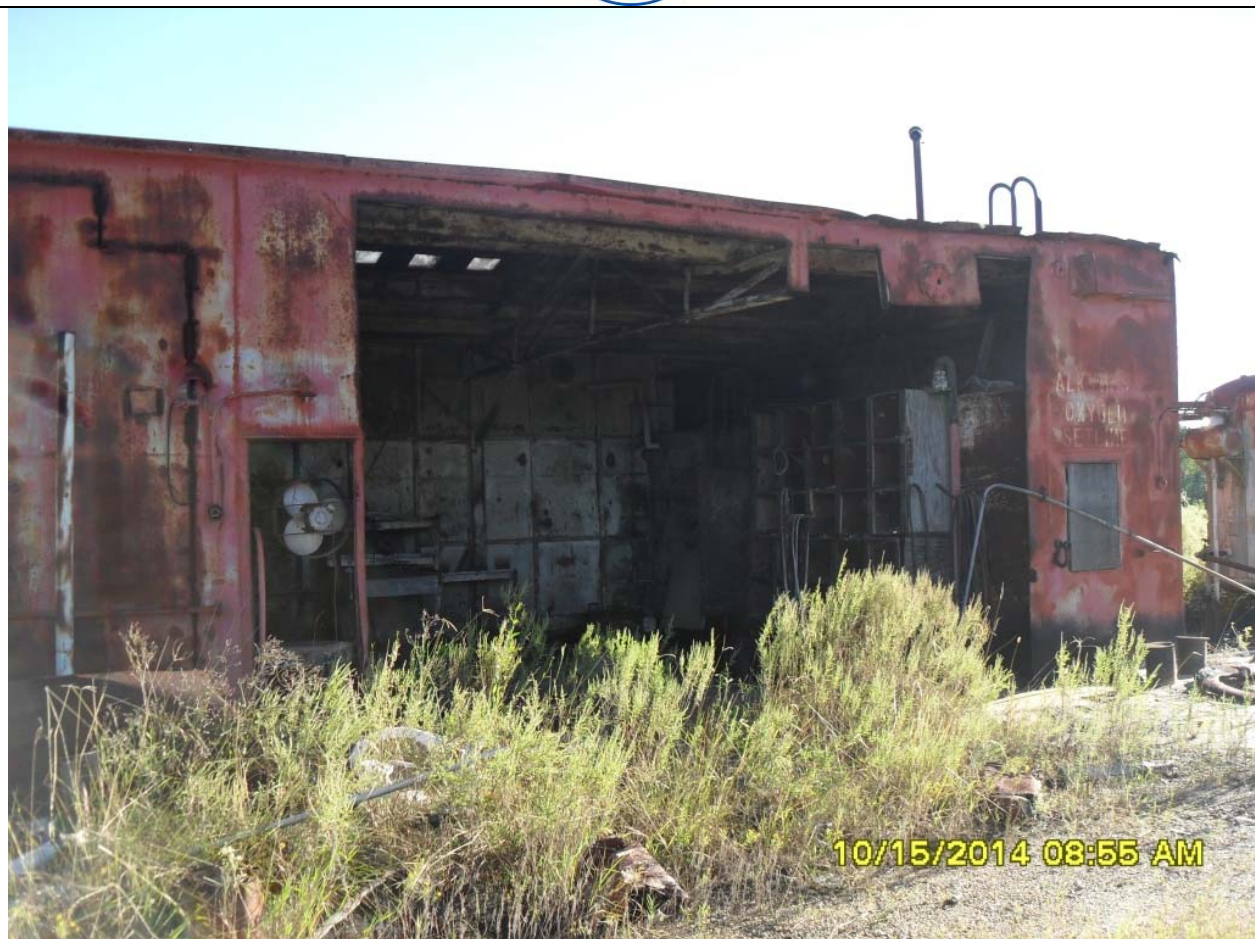
Logbook Photo #	SDC10043
US EPA ID / Task Order Number	CERCLIS No. LAD008434185 / 2/Dynamac-077-15-001
Site	SBA Shipyard, Inc. – Removal Assessment (RA)
Location Address	9040 Castex Landing Road
City, State	Jennings, Louisiana
Parish	Jefferson Davis
Direction/Orientation	NE
Date	10/15/14
Time	0855 hrs
Photographer	J. Sherrard (START)
Witness	N. Biscocho (START)
Description: Current condition of the alkyne storage tank pump house visible on the buried barge. South wall of the alkyne storage tank pump house facing northwest.

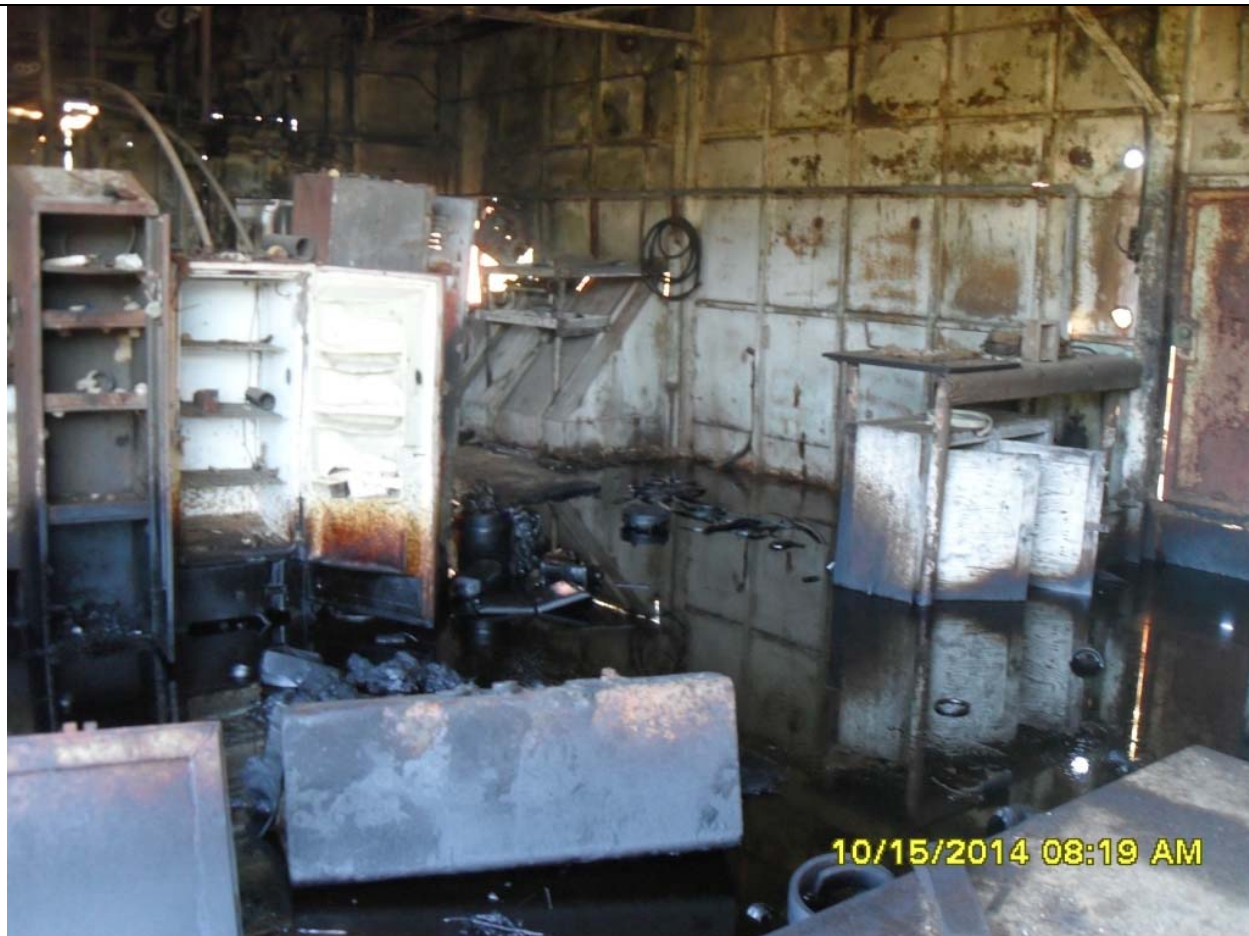
Logbook Photo #	SDC10009
US EPA ID / Task Order Number	CERCLIS No. LAD008434185 / 2/Dynamac-077-15-001
Site	SBA Shipyard, Inc. – Removal Assessment (RA)
Location Address	9040 Castex Landing Road
City, State	Jennings, Louisiana
Parish	Jefferson Davis
Direction/Orientation	NW
Date	10/15/14
Time	0819 Hrs
Photographer	N. Biscocho (START)
Witness	J. Sherrard (START)
Description:	
View inside the alkyne storage tank pump house visible on the buried barge, facing northwest.	
Water and oil mixture observed in the interior of the alkyne storage tank pump house structure.

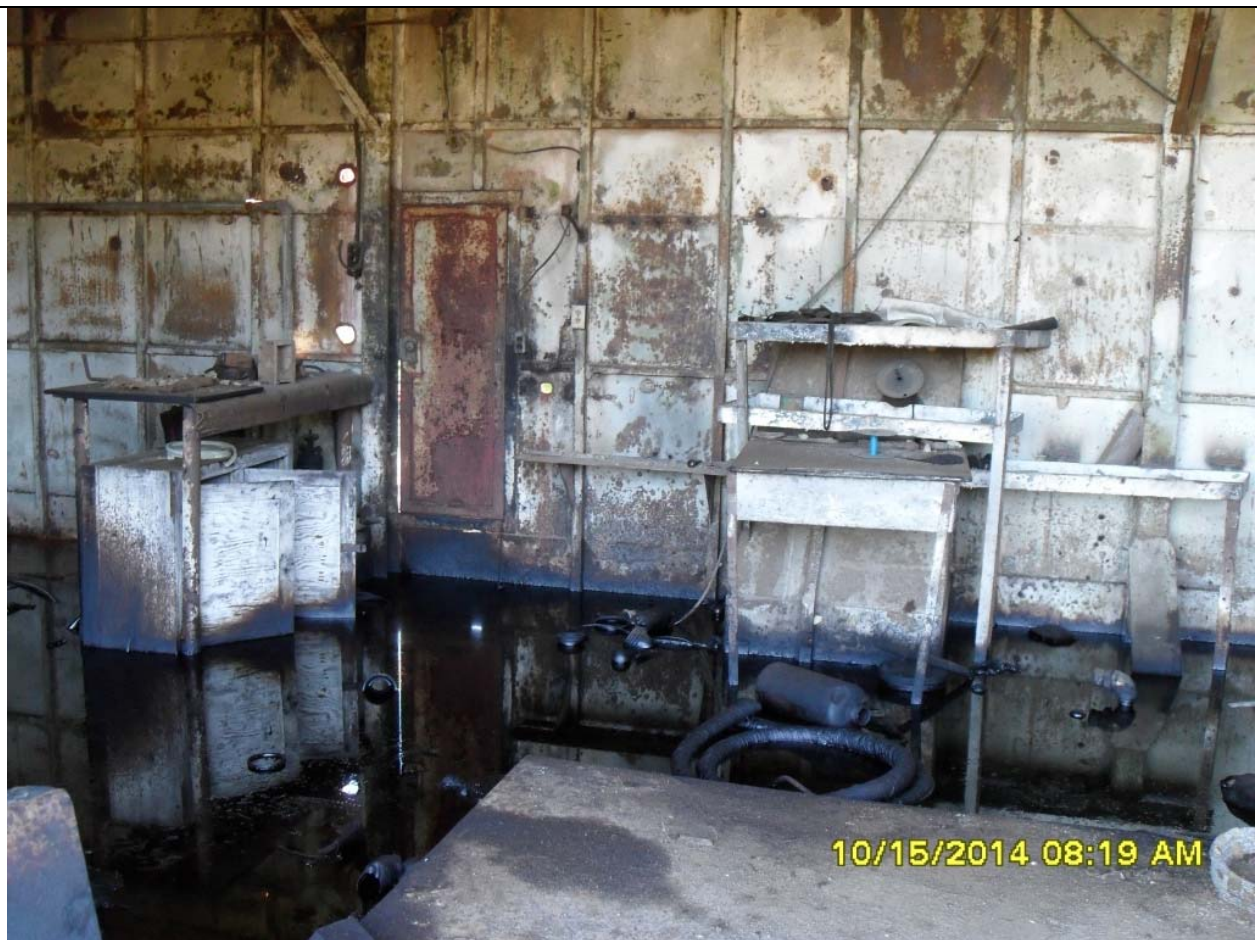
Logbook Photo #	SDC10010
US EPA ID / Task Order Number	CERCLIS No. LAD008434185 / 2/Dynamac-077-15-001
Site	SBA Shipyard, Inc. – Removal Assessment (RA)
Location Address	9040 Castex Landing Road
City, State	Jennings, Louisiana
Parish	Jefferson Davis
Direction/Orientation	N
Date	10/15/14
Time	0819 hrs
Photographer	N. Biscocho (START)
Witness	J. Sherrard (START)
Description:	<p>View inside the alkyne storage tank pump house visible on the buried barge, facing north.</p> <p>Water and oil mixture observed in the interior of the alkyne storage tank pump house structure.</p>

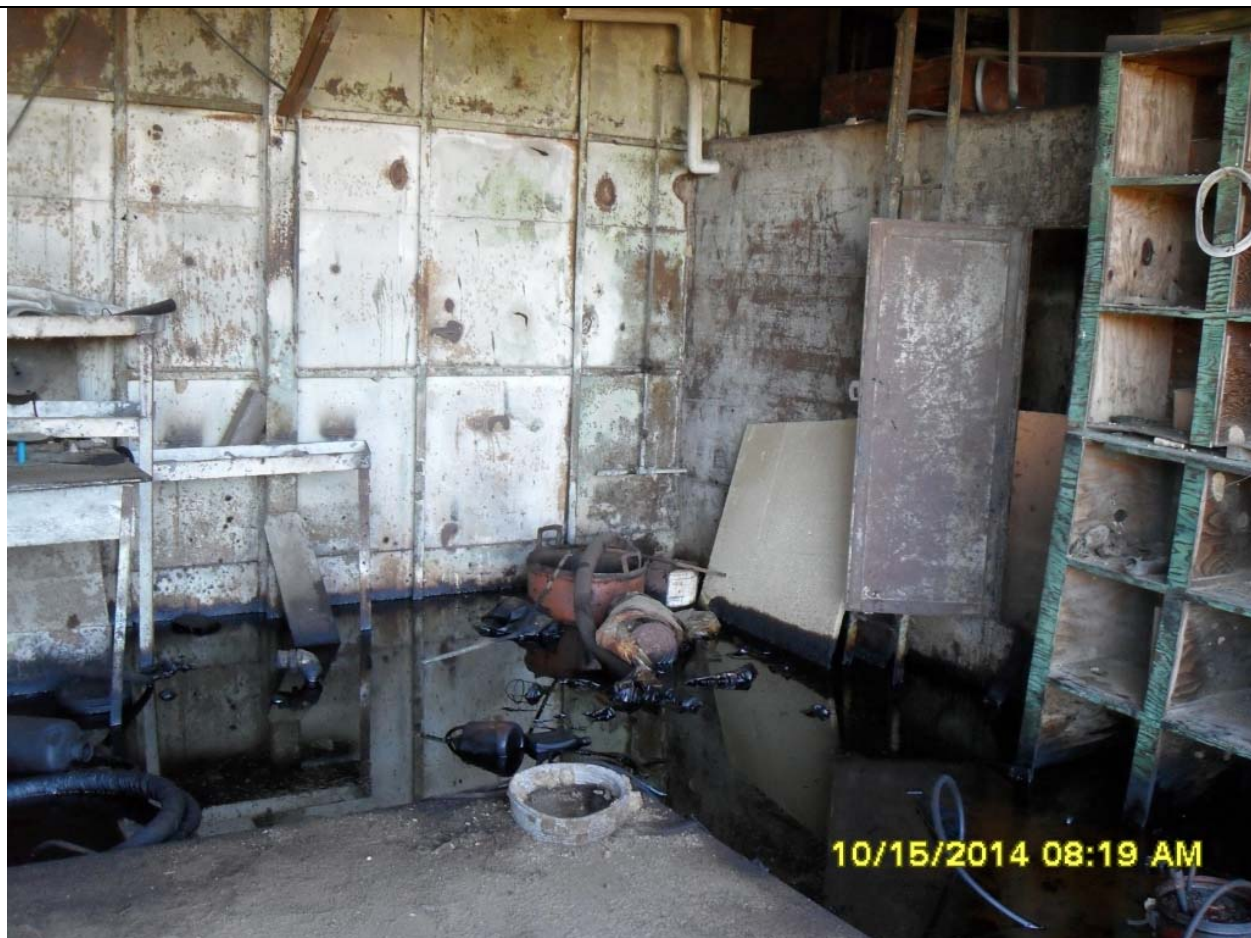
Logbook Photo #	SDC10011
US EPA ID / Task Order Number	CERCLIS No. LAD008434185 / 2/Dynamac-077-15-001
Site	SBA Shipyard, Inc. – Removal Assessment (RA)
Location Address	9040 Castex Landing Road
City, State	Jennings, Louisiana
Parish	Jefferson Davis
Direction/Orientation	NE
Date	10/15/14
Time	0819 hrs
Photographer	N. Biscocho (START)
Witness	J. Sherrard (START)
Description: View inside the alkyne storage tank pump house visible on the buried barge, facing northeast. Water and oil mixture observed in the interior of the alkyne storage tank pump house structure.

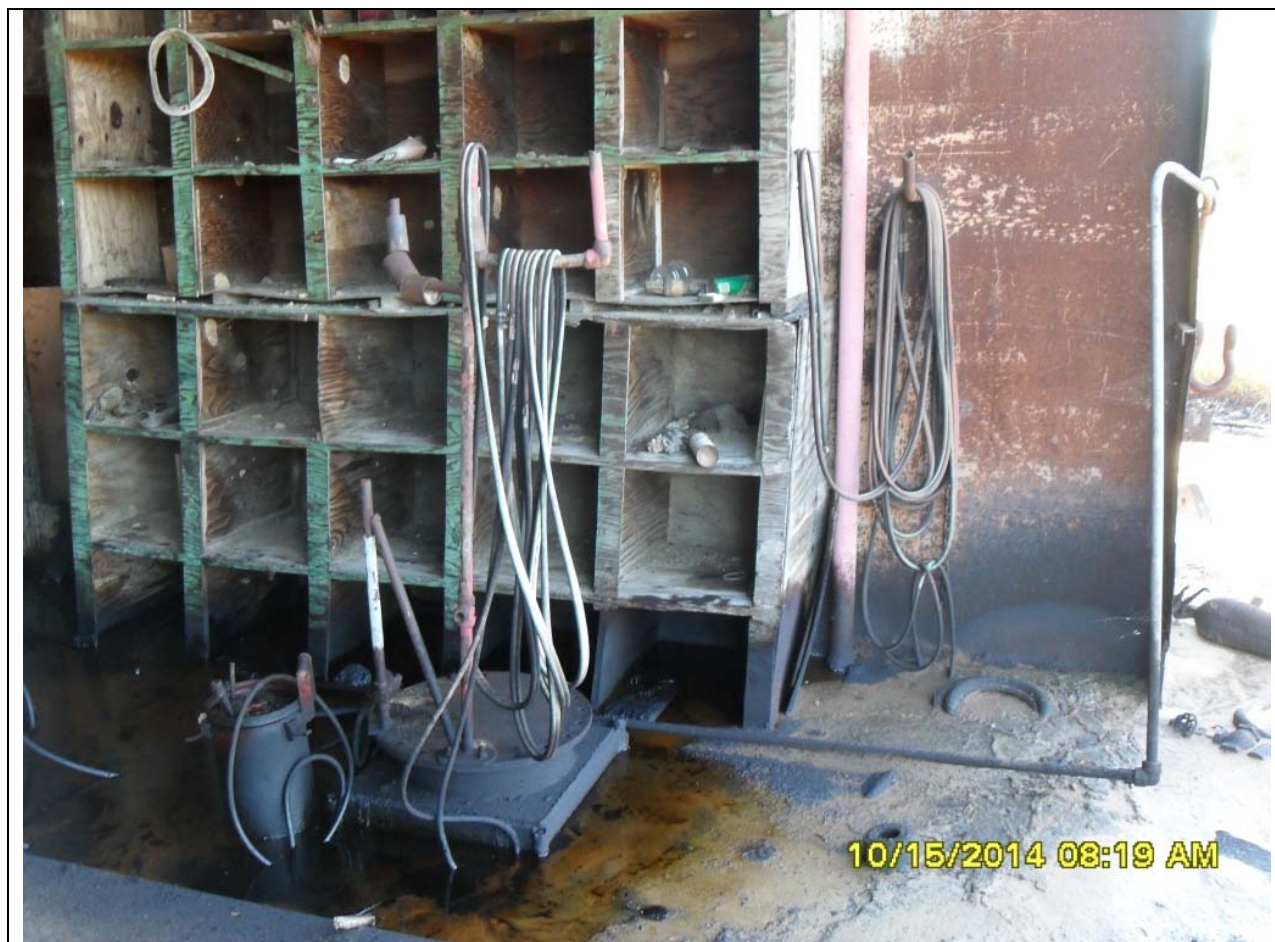
Logbook Photo #	SDC10012
US EPA ID / Task Order Number	CERCLIS No. LAD008434185 / 2/Dynamac-077-15-001
Site	SBA Shipyard, Inc. – Removal Assessment (RA)
Location Address	9040 Castex Landing Road
City, State	Jennings, Louisiana
Parish	Jefferson Davis
Direction/Orientation	E
Date	10/15/14
Time	0819 hrs
Photographer	N. Biscocho (START)
Witness	J. Sherrard (START)
Description:	<p>View inside the alkyne storage tank pump house visible on the buried barge, facing east.</p> <p>Water and oil mixture observed in the interior of the alkyne storage tank pump house structure.</p>

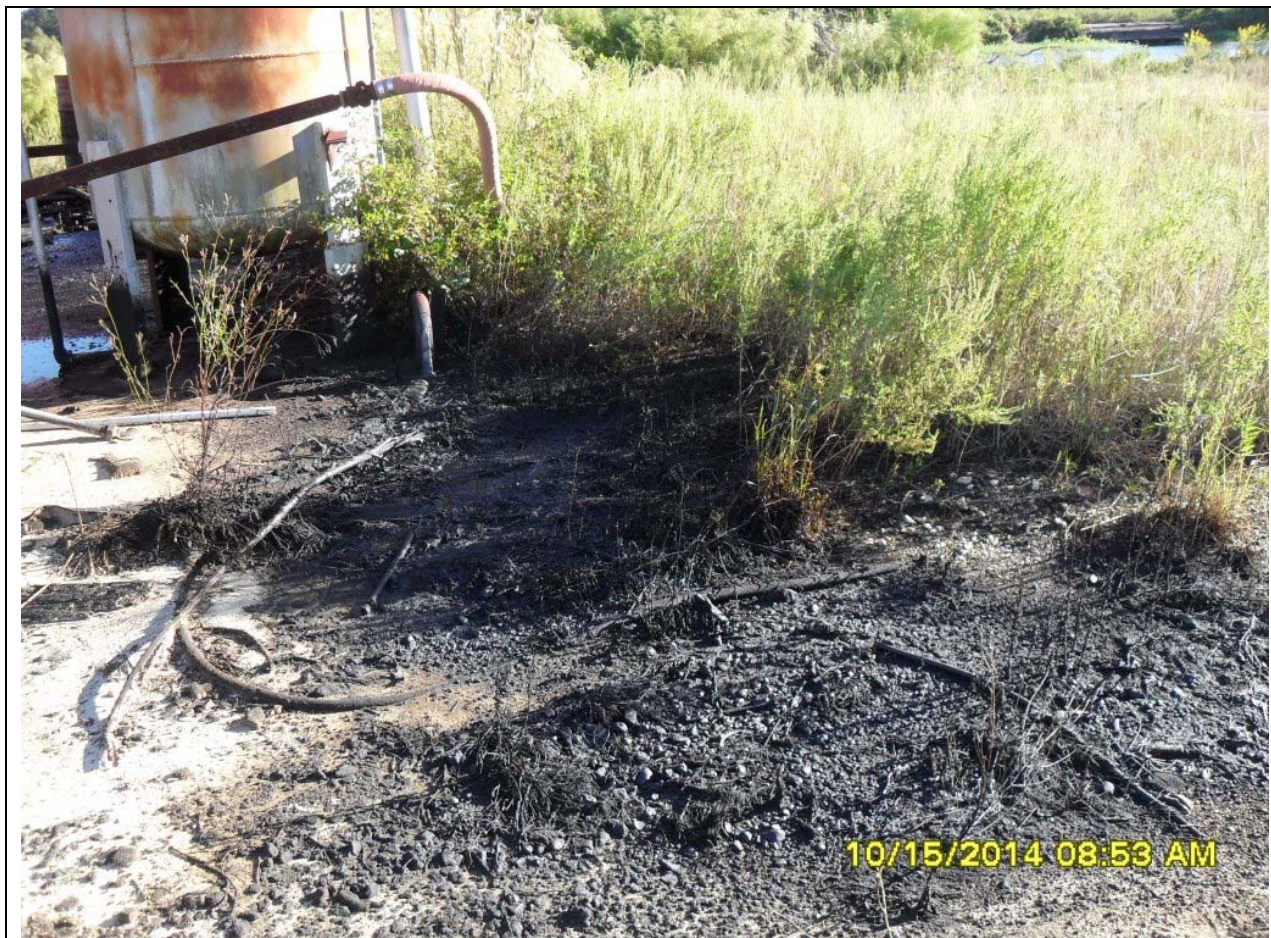
Logbook Photo #	SDC10034
US EPA ID / Task Order Number	CERCLIS No. LAD008434185 / 2/Dynamac-077-15-001
Site	SBA Shipyard, Inc. – Removal Assessment (RA)
Location Address	9040 Castex Landing Road
City, State	Jennings, Louisiana
Parish	Jefferson Davis
Direction/Orientation	N
Date	10/15/14
Time	0853 hrs
Photographer	J. Sherrard (START)
Witness	N. Biscocho (START)
Description:	
Stained soil from the buried barge associated with the alkyne storage tank pump house.	
Stained soil observed adjacent to the above ground storage tank (AST) on the east side of the alkyne storage tank pump house.

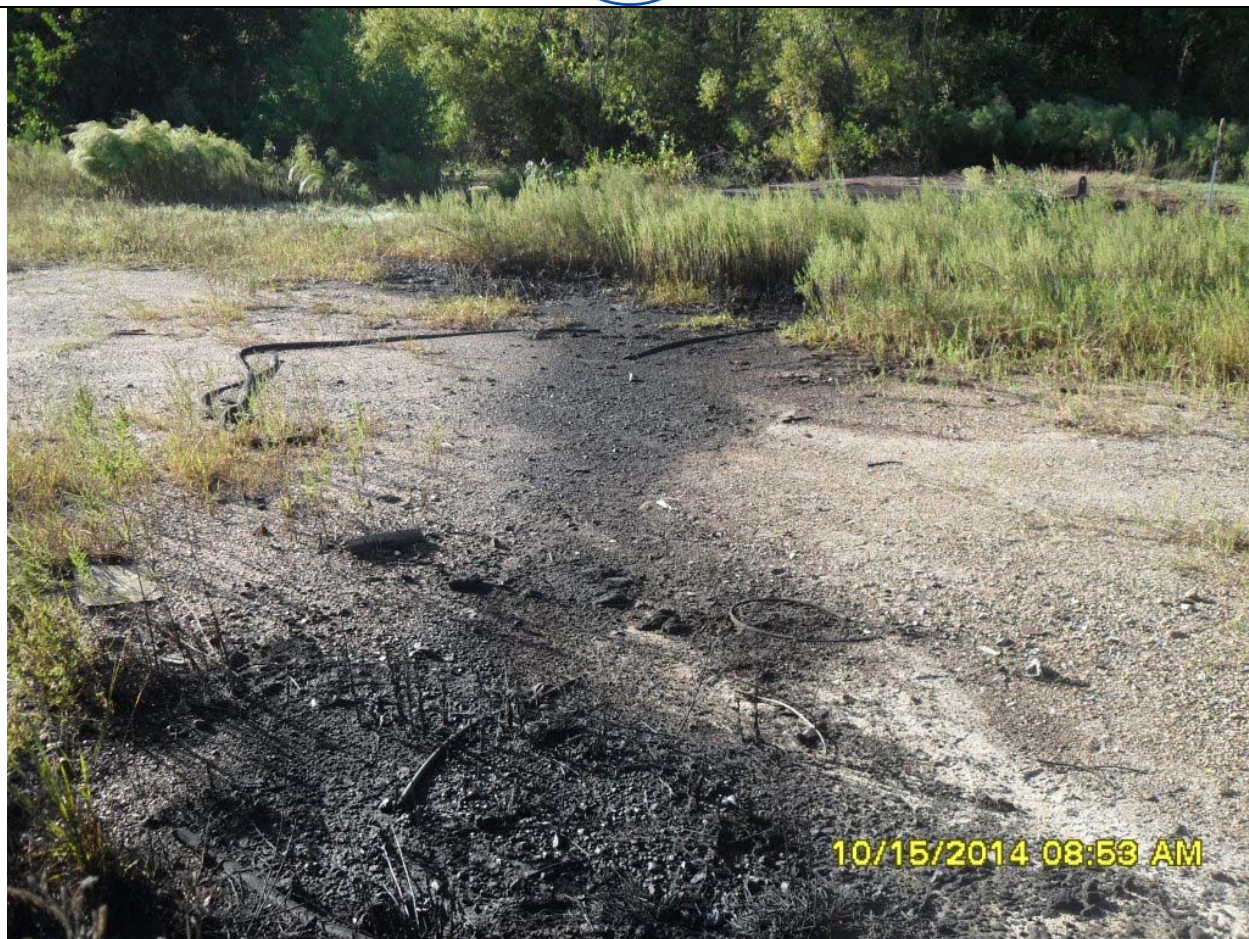
Logbook Photo #	SDC10036
US EPA ID / Task Order Number	CERCLIS No. LAD008434185 / 2/Dynamac-077-15-001
Site	SBA Shipyard, Inc. – Removal Assessment (RA)
Location Address	9040 Castex Landing Road
City, State	Jennings, Louisiana
Parish	Jefferson Davis
Direction/Orientation	SE
Date	10/15/14
Time	0853 hrs
Photographer	J. Sherrard (START)
Witness	N. Biscocho (START)
Description: Stained soil from the buried barge associated with the alkyne storage tank pump house. Looking southeast stained soil observed from the alkyne storage tank pump house, along the south side of the structure, to the drain ditch adjacent to the wetland.

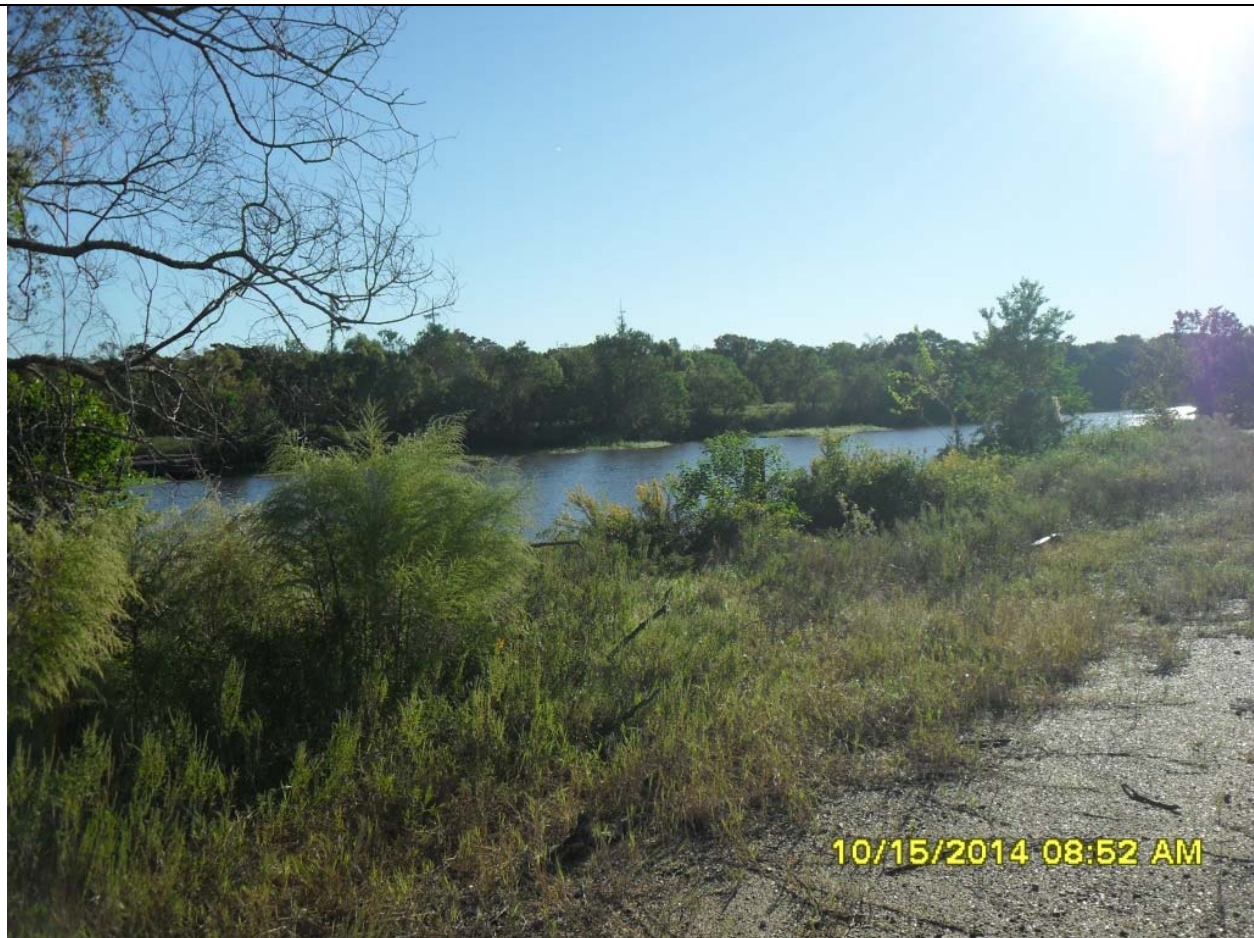
Logbook Photo #	SDC10030
US EPA ID / Task Order Number	CERCLIS No. LAD008434185 / 2/Dynamac-077-15-001
Site	SBA Shipyard, Inc. – Removal Assessment (RA)
Location Address	9040 Castex Landing Road
City, State	Jennings, Louisiana
Parish	Jefferson Davis
Direction/Orientation	NE
Date	10/15/14
Time	0852 hrs
Photographer	N. Biscocho (START)
Witness	J. Sherrard (START)
Description: Overview of the site surrounding the buried barge associated with the alkyne storage tank pump house. Barge slip located north of the alkyne storage tank pump house.

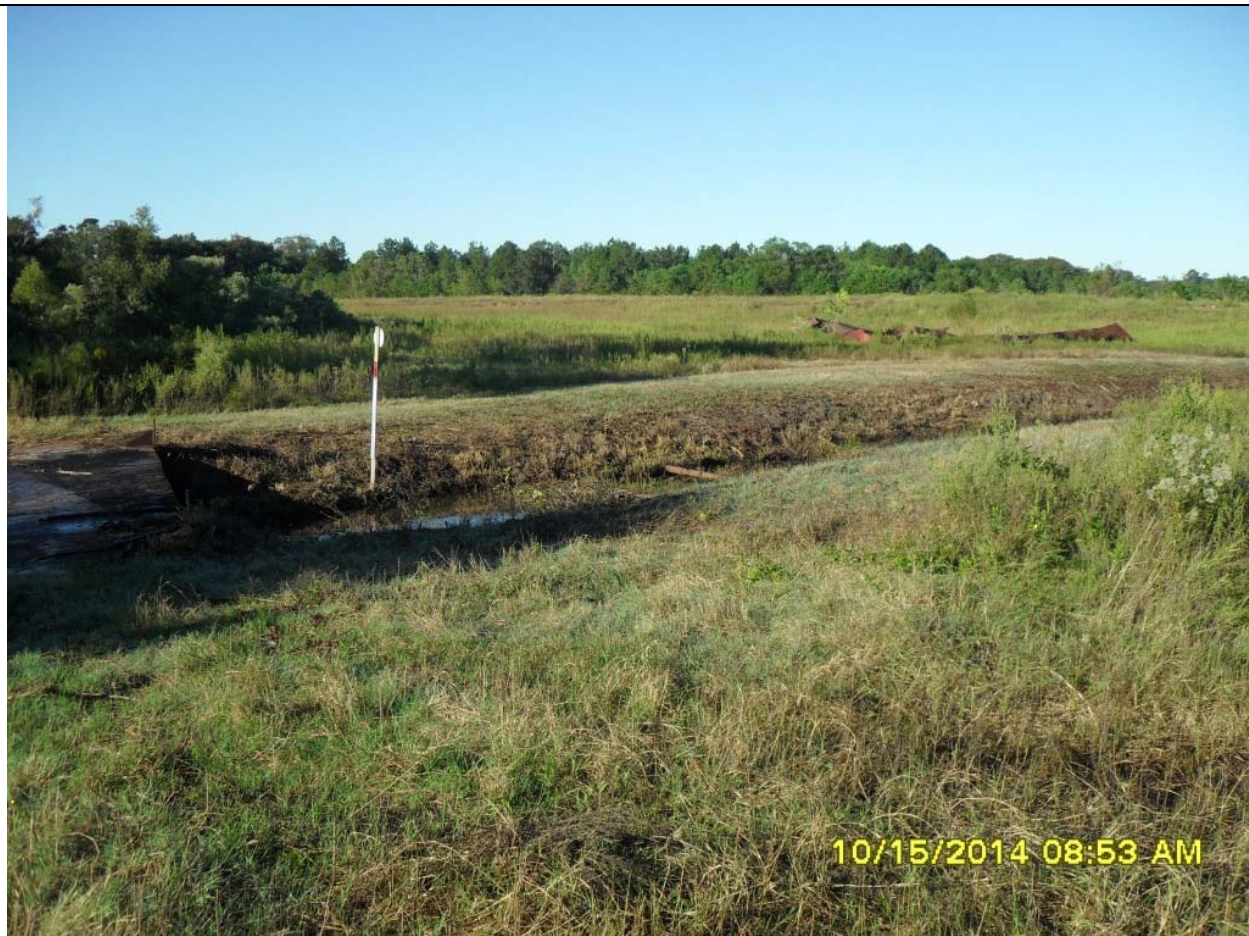
Logbook Photo #	SDC10031
US EPA ID / Task Order Number	CERCLIS No. LAD008434185 / 2/Dynamac-077-15-001
Site	SBA Shipyard, Inc. – Removal Assessment (RA)
Location Address	9040 Castex Landing Road
City, State	Jennings, Louisiana
Parish	Jefferson Davis
Direction/Orientation	SW
Date	10/15/14
Time	0853 hrs
Photographer	N. Biscocho (START)
Witness	J. Sherrard (START)
Description: Overview of the site surrounding the buried barge associated with the alkyne storage tank pump house. Facing south from the alkyne storage tank pump house.

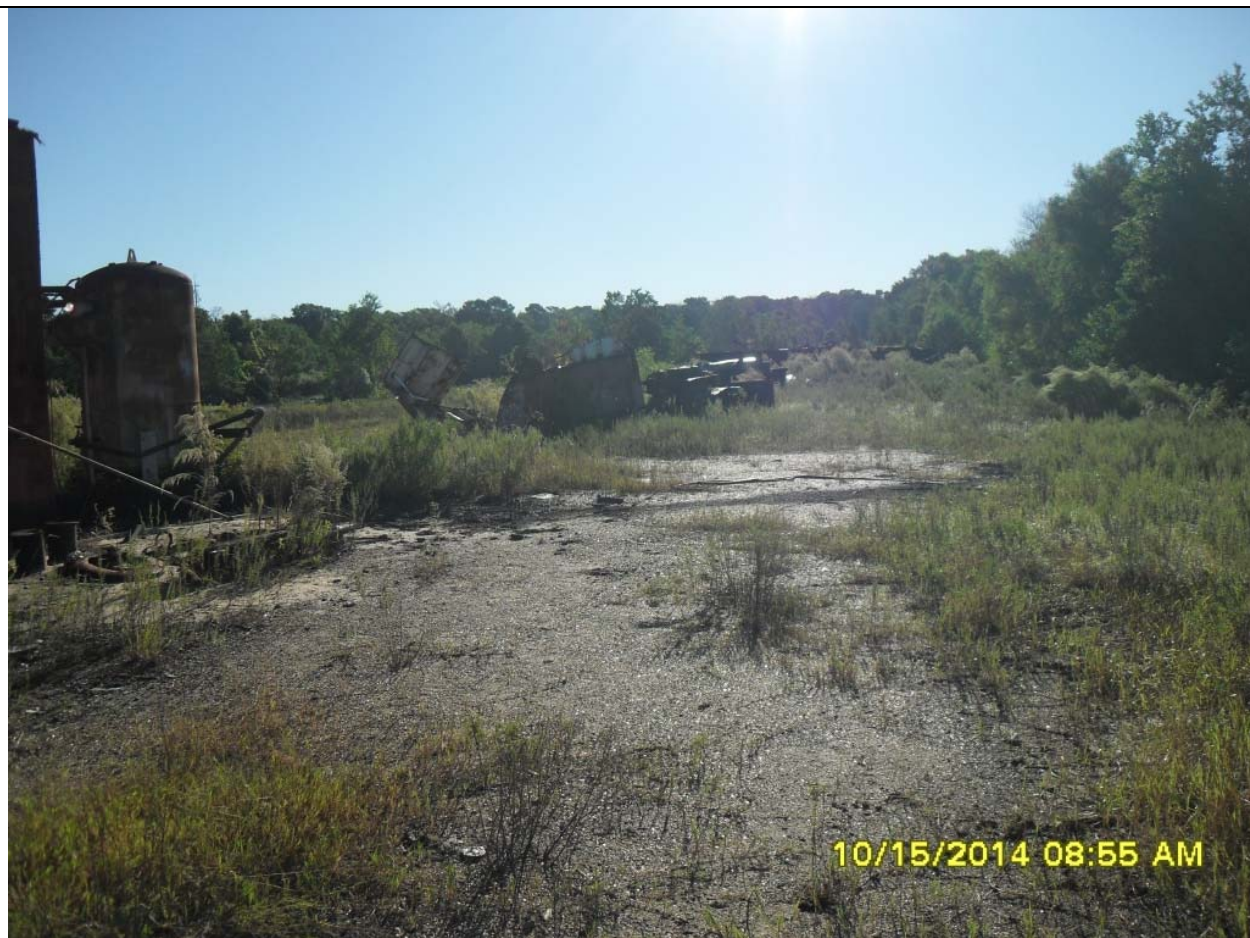
Logbook Photo #	SDC10044
US EPA ID / Task Order Number	CERCLIS No. LAD008434185 / 2/Dynamac-077-15-001
Site	SBA Shipyard, Inc. – Removal Assessment (RA)
Location Address	9040 Castex Landing Road
City, State	Jennings, Louisiana
Parish	Jefferson Davis
Direction/Orientation	E
Date	10/15/14
Time	0855 hrs
Photographer	J. Sherrard (START)
Witness	N. Biscocho (START)
Description: Overview of site surrounding the buried barge associated with the alkyne storage tank pump house. Facing east toward the buried barge.
